Building Explosion and Fire  
Silver Spring, Maryland  
August 10, 2016

**Accident Report**

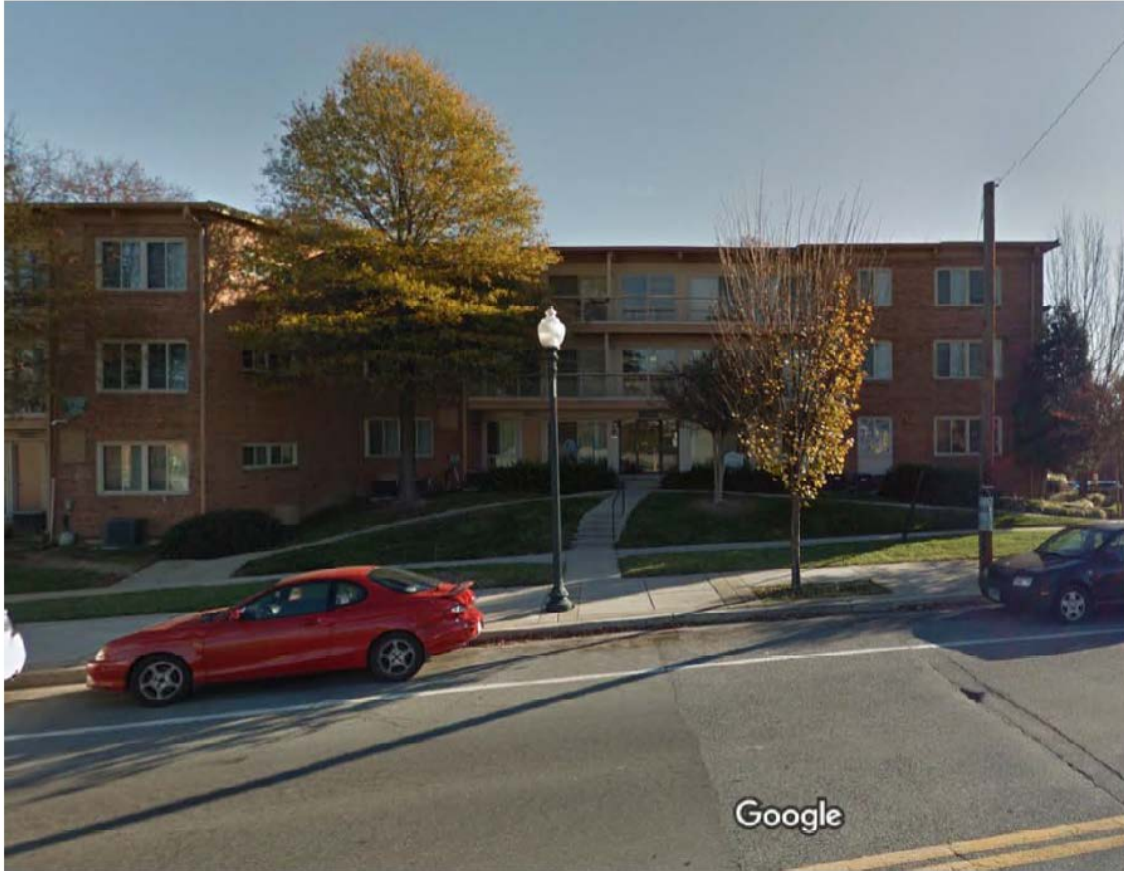
**Figure 1.** The accident location, 8701 Arliss Street, before the August 10, 2016, explosion. (Photograph from Google Earth, dated November 2015.)

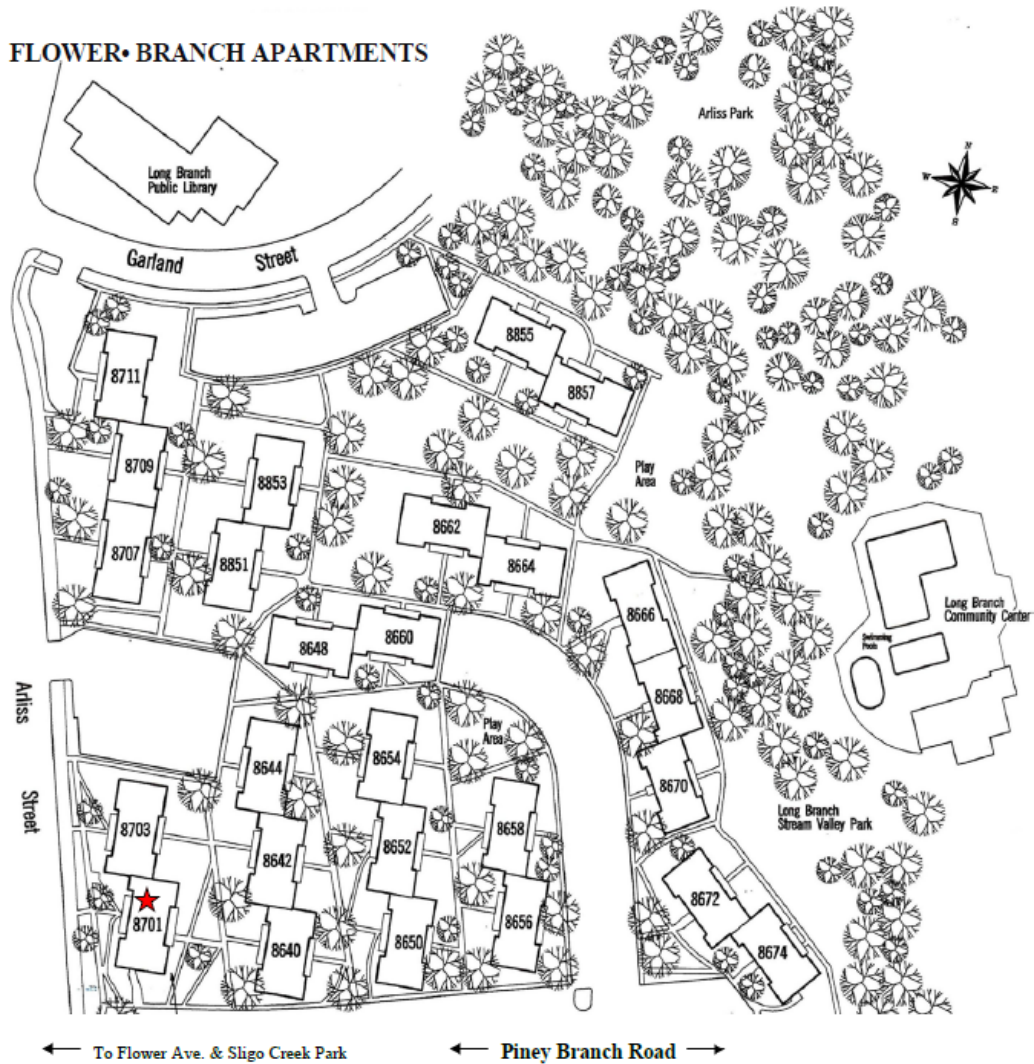
**Figure 3.** Layout of the Flower Branch apartment complex. Building 8701 is identified by a red star. (Graphic provided by Kay Management.)

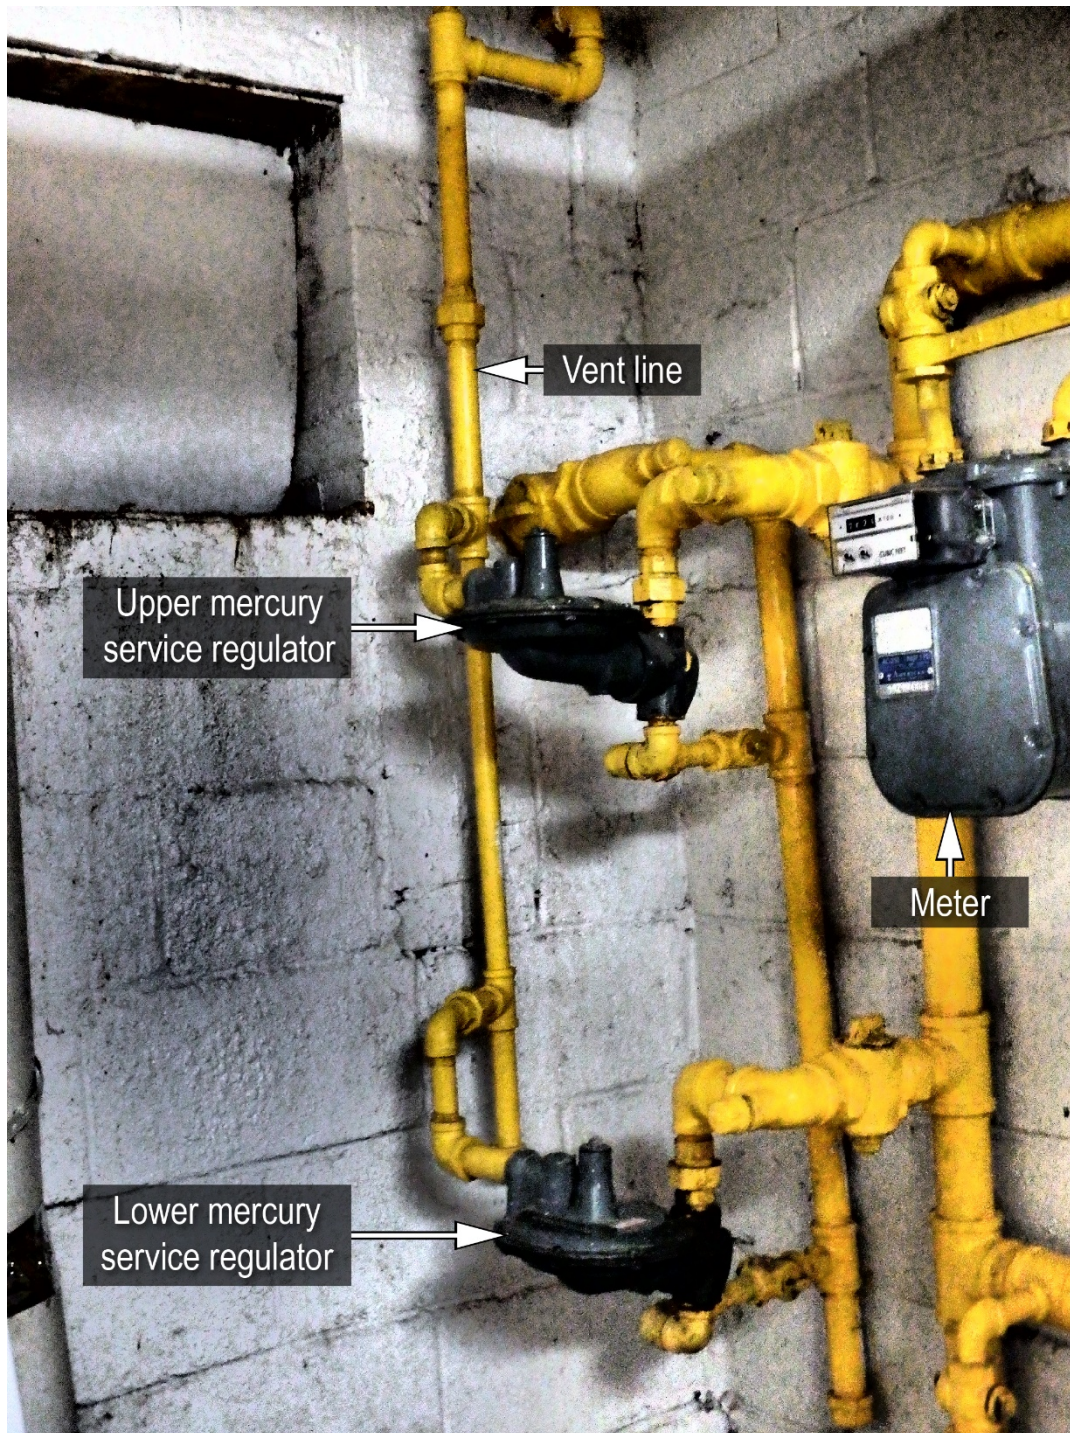
**Figure 7.** Exemplar configuration of a mercury service regulator assembly in a similar Flower Branch apartment building.

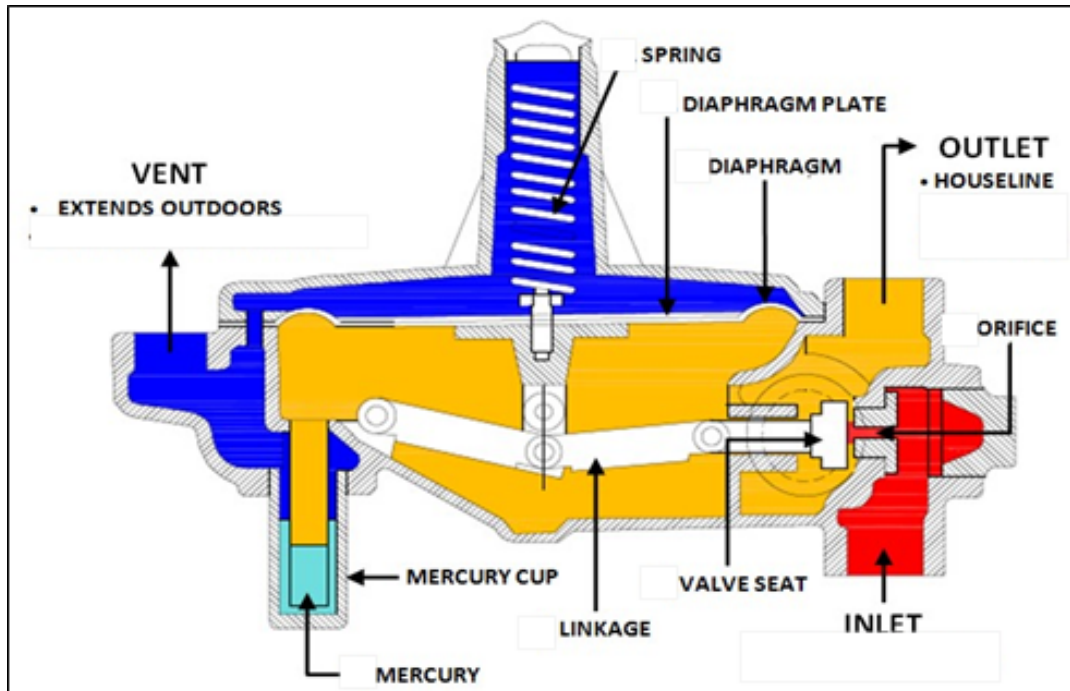
**Figure 9.** Cross sectional image of a mercury service regulator. (Diagram provided by WG.)

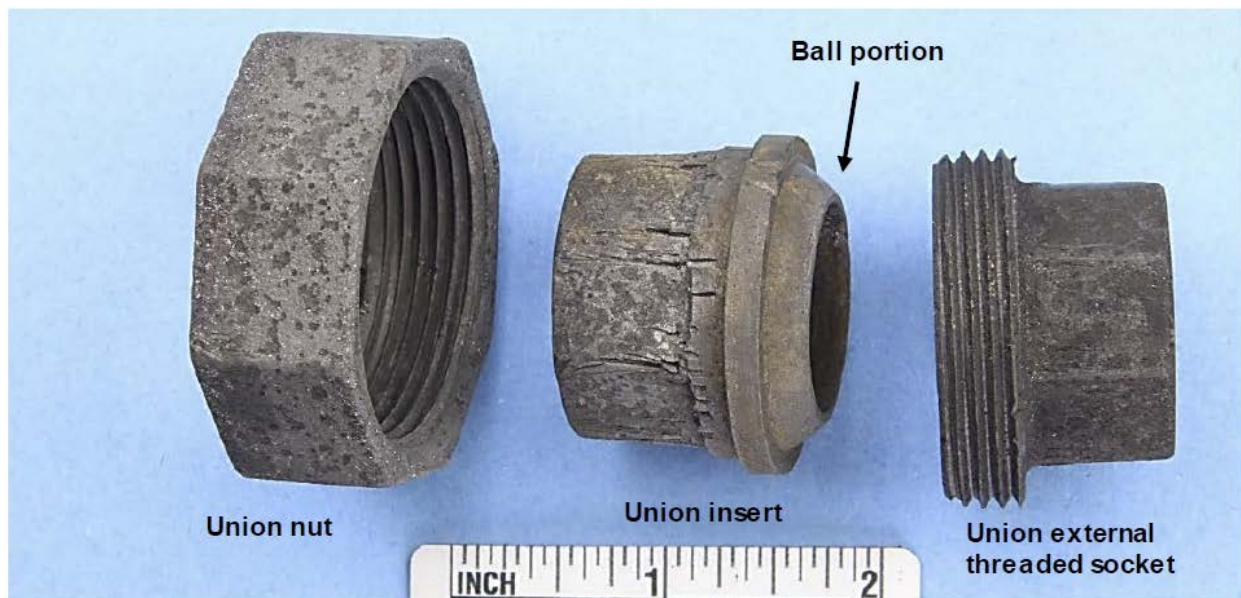
**Figure 13.** Photograph of the disassembled union assembly for the accident lower gas regulator after cleaning.

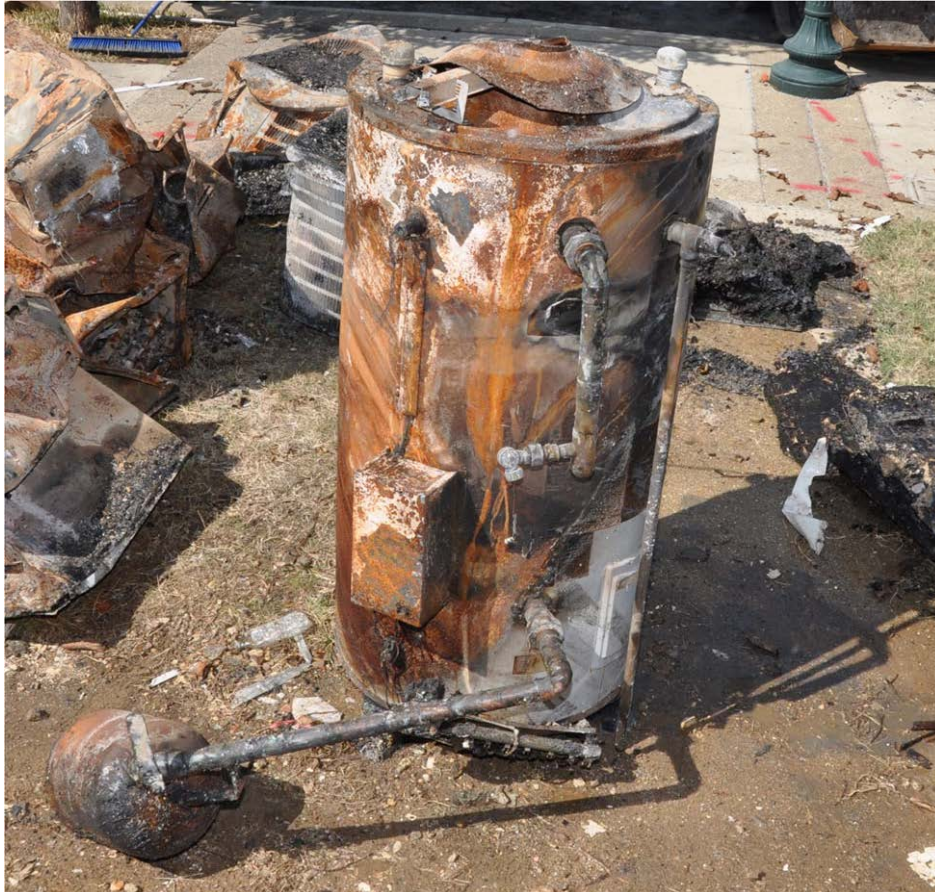
**Figure 14.** Hot water heater at the accident scene after the explosion. (Photograph provided by ATF.)

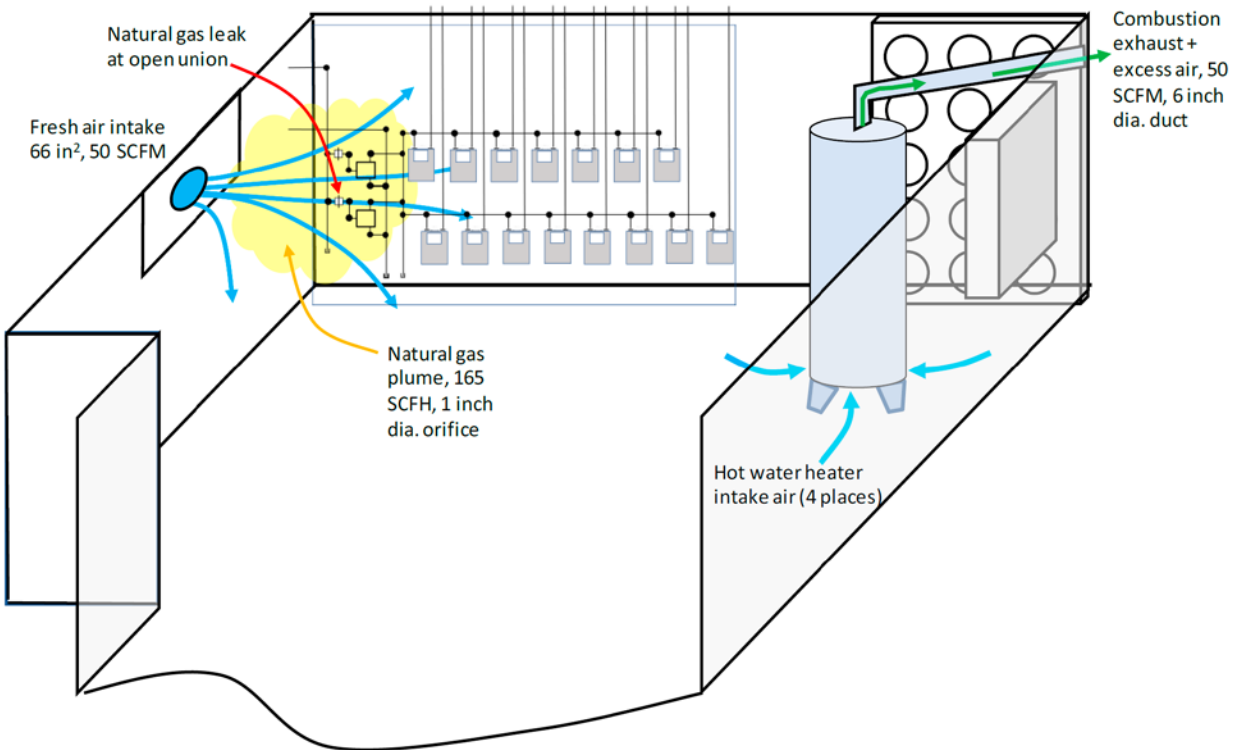
**Figure 16.** Three-dimensional visualization of the meter room.
